MECHANICAL CODE DISCUSSION

Energy & Mechanical Code Failure — Access to HVAC Systems in Attics

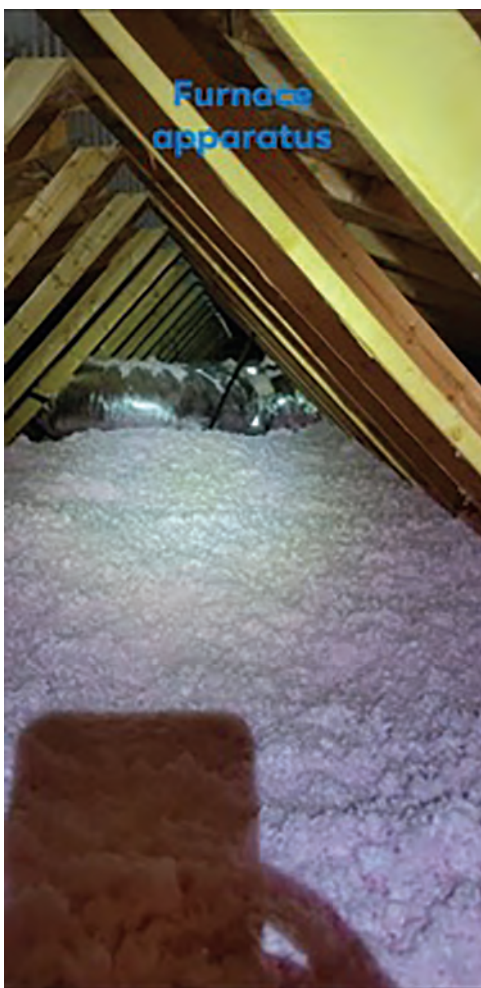
I recently received a call from good friends who purchased a getaway home in Southern Utah, with questions including several on their HVAC system. As we discussed their questions over the course of several weeks, I asked if they could provide a few photos of the HVAC system in the attic, specifically the furnace, coil, and duct, expecting they could easily access the service platform in front of the furnace. Hmmm . . . no, this is what I received

from their son-in-law who lives close by:

Yes, that’s the furnace, 24’ from the access. I will not quote my exact comments uttered when I received this as some might be offended.

1. Where access is poor, maintenance is rarely performed, failures more common and require greater time and expense. I appreciate how many of you install filter grills; however, the appliance needs more than a simply filter change. Don't you sell service plans, performing much more?
2. This home is in Climate Zone 3, in an area where virtually all the furnaces are installed in attics. Logically, this area should be the most proactive in compliance with this section?
3. Crawling through the insulation disturbs and packs down the insulation, reducing the effective R-value of the attic insulation. Referring the photo above, is it

possible to return the insulation to this fluffed up effective condition, after multiple trips to and from the appliance? Also, notice the return plenum does not appear to be insulated.

We find in the **2000 IRC**, Section M1305.1.3, requirements including access size, a distance not more than 20’ from appliance to access, a continuous

24” wide floor/catwalk above the insulation, a level service platform minimum 30” deep in front of sides requiring access, a light at the appliance controlled at the access, and a service receptacle near the appliance. Isn’t 22 years long enough for the design professionals, code officials, contractors, and sub-contractors to get up to speed?

In the **2006 IRC**, an exception was added allowing a 22” wide catwalk, 50’ long if there is 6’ high clearance from the access to the appliance. This section remains unchanged in the **2009, 2012, 2015, 2018, and 2021 IRC**. If the height is less than 6’, the distance from access to appliance is limited to 20’.

9. Lastly, a reminder, IRC N1102.2.4 requires full depth insulation to be permanently attached to the access panel, baffles to prevent insulation spilling, a weather strip on the panel and access to appliance which prevents damaging or compressing the insulation.

Maybe the best solution is getting the furnace out of the . . . attic.
